7 NORWICH QUAY, LYTTELTON: REPORT ON ARCHAEOLOGICAL MONITORING

NZHPT AUTHORITIES 2012/108EQ & 2012/256EQ

ANDY DODD AND KATHARINE WATSON
UNDERGROUND OVERGROUND ARCHAEOLOGY LTD

NOVEMBER 2012

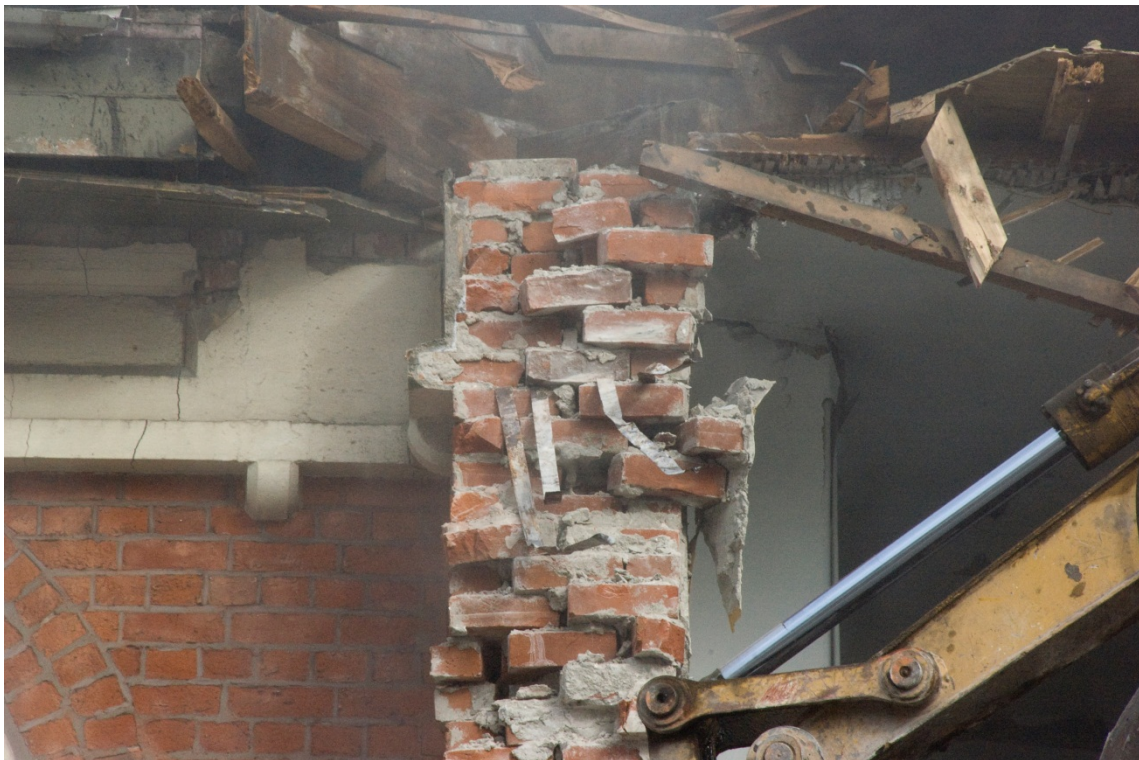
Figure 6. The brick walls of the first floor of 7 Norwich Quay, showing the English bond brickwork and the hoop iron used as reinforcing. Note, however, that in the 16 courses of brickwork shown, there is only one layer of hoop iron reinforcing.

As noted above, the building was brick and the walls on both the ground and first floors were quadruple brick, laid in English bond (Figure 6). This is unusual in 19th century brick buildings, as the number of bricks per course generally reduces with each floor of the building. It is tempting to suggest that this was not the case in the post office because it was a government building and thus well built, with no expense spared. The walls were reinforced with hoop iron (Figure 6). The bricks were 'S' bricks, and some of those used under the Portland cement were special shaped bricks (Figure 7 and Figure 8). These bricks were made by Smith and Stead (Bickler 2007).

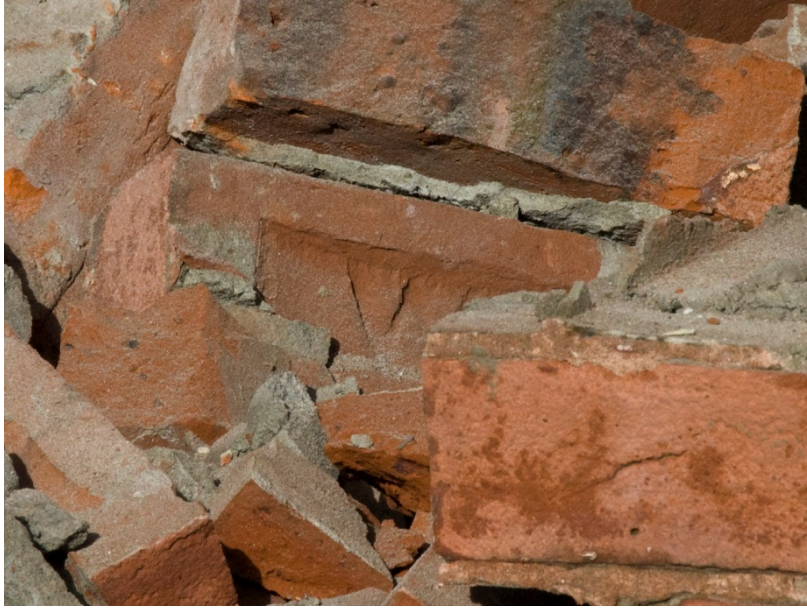
Figure 9. A 'W' brick from the lean-to.

The bricks used in the lean-to were 'W' bricks, made by the Wigram brickworks, which operated from 1886 on (Figure 9; Bickler 2007). As such, the lean-to must have been built after 1886. The walls of the lean-to were double-brick and were laid in English bond (Figure 10).

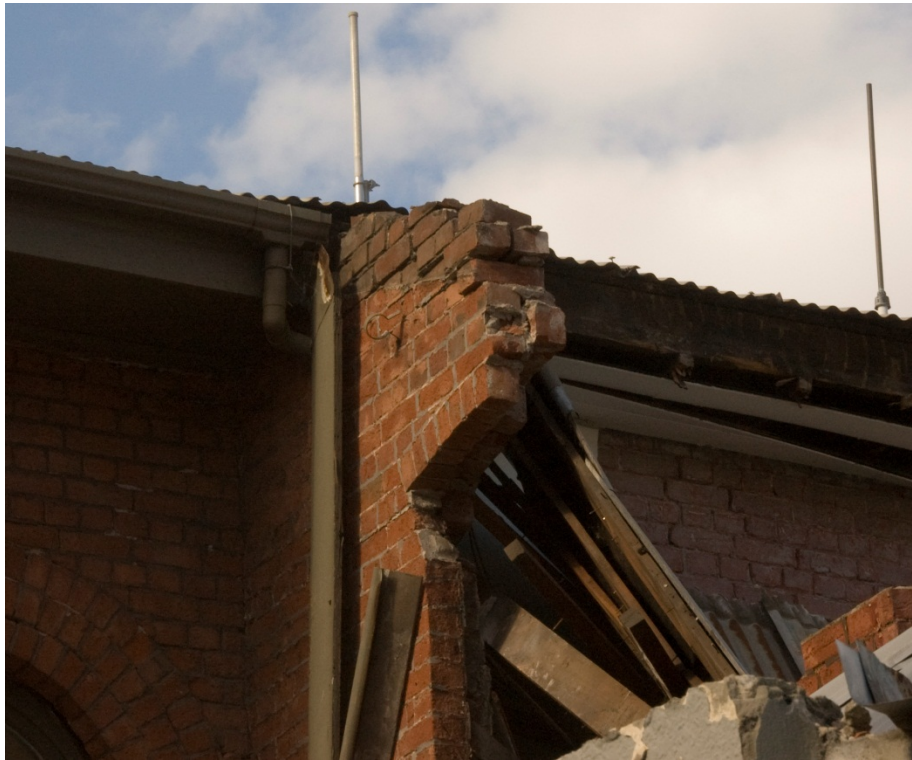
Figure 10. The north wall of the lean-to, showing the brickwork.

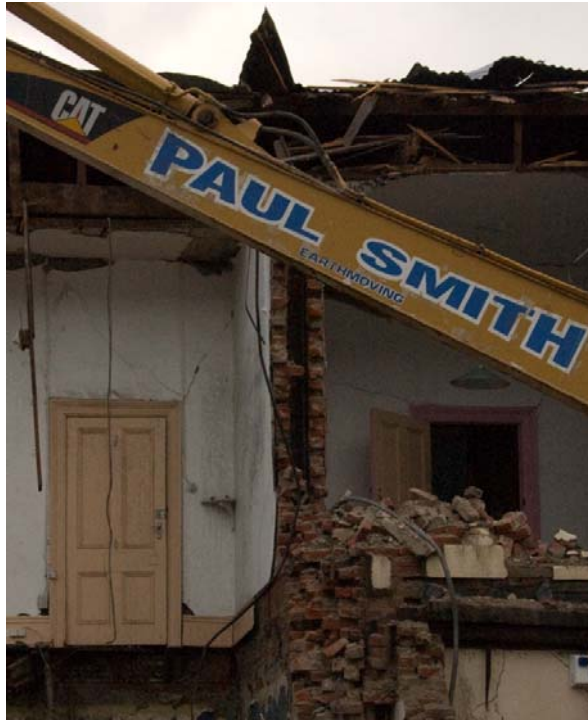
Figure 11. An interior wall on the first floor, showing a cavity that was probably related to the air flues used to ventilate the building.

The observed internal walls were all brick (the scale and extent of demolitions in Christchurch at this time meant that it was not possible to observe the demolition of 7 Norwich Quay continuously). These walls were double brick and some appeared to have cavities in them (Figure 11). It is likely that these were related to the air flues mentioned in the *Press* (Figure 5; *Press* 12/7/1875: 2).

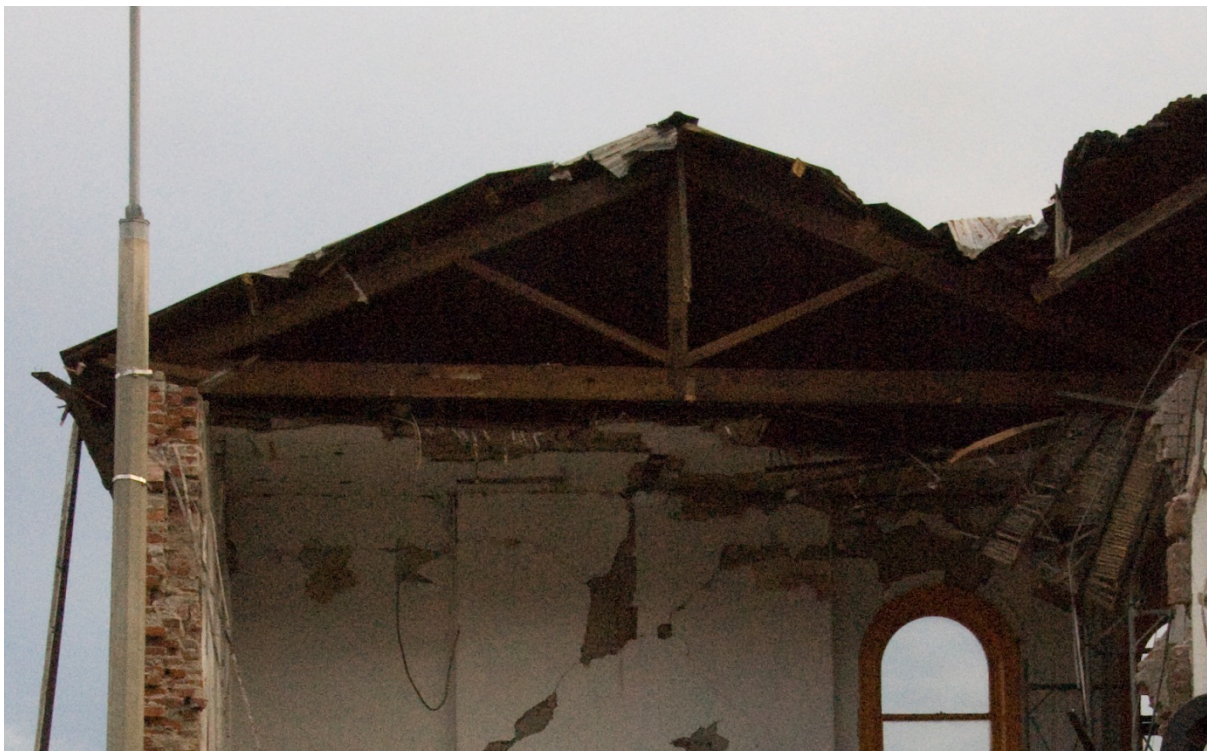
Figure 12. The roof trusses in the east bay of 7 Norwich Quay.

Each wing of the main building had a hipped roof, and the roof trusses were king trusses (Figure 12). Additional bracing had been added to at least one of the trusses (Figure 13), and some construction marks were observed on this. The trusses were held together by a mixture of metal strapping and nails, with a system of gibs and cotters used to fasten the truss (Figure 14 and Figure 15). Sarking sat on top of the purlins and under the corrugated iron.

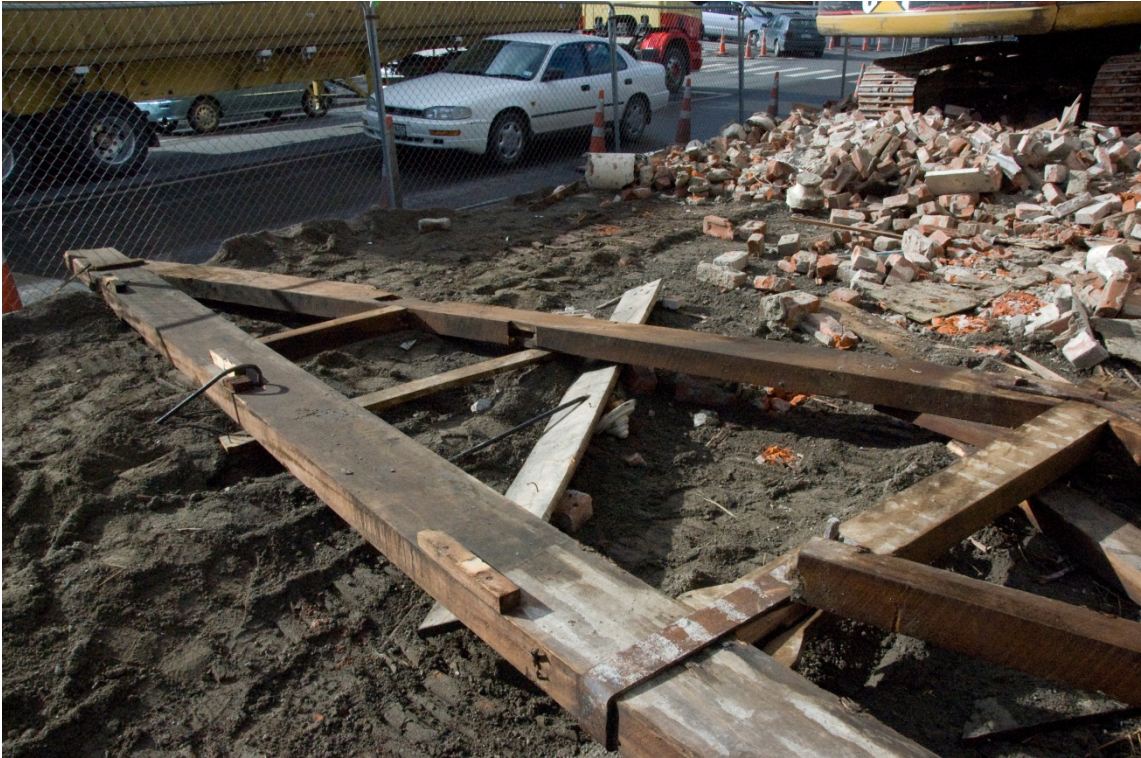
Figure 13. A roof truss, with additional bracing. Note also the staining on the king post, which could be from lath and plaster.

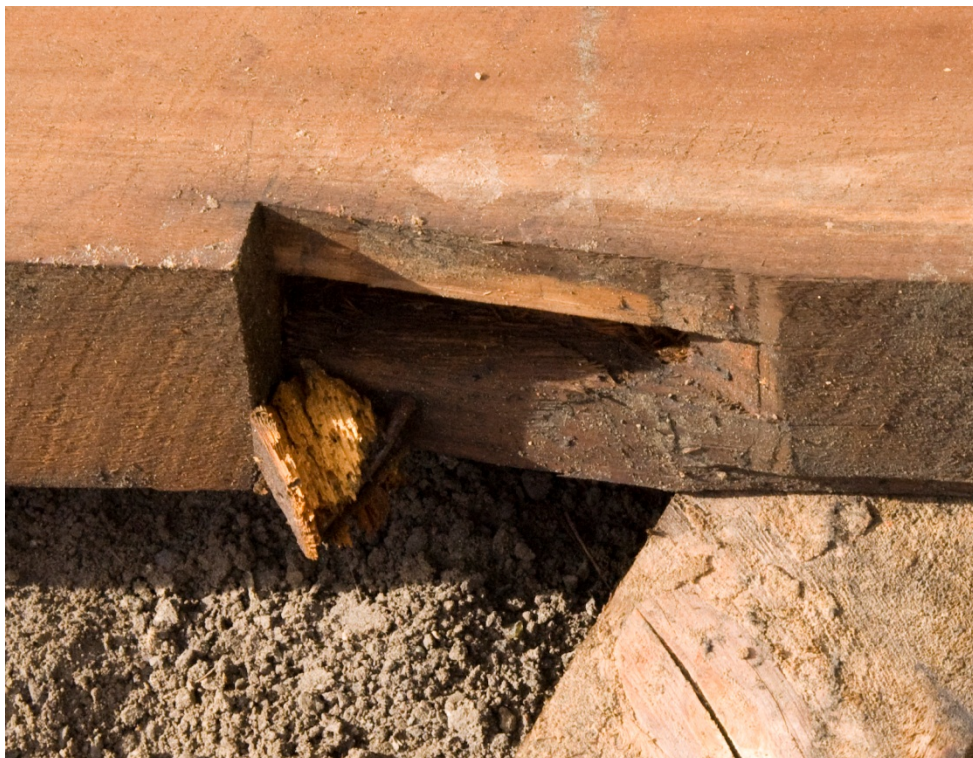
Figure 14. A cut nail used in the construction of a roof truss.

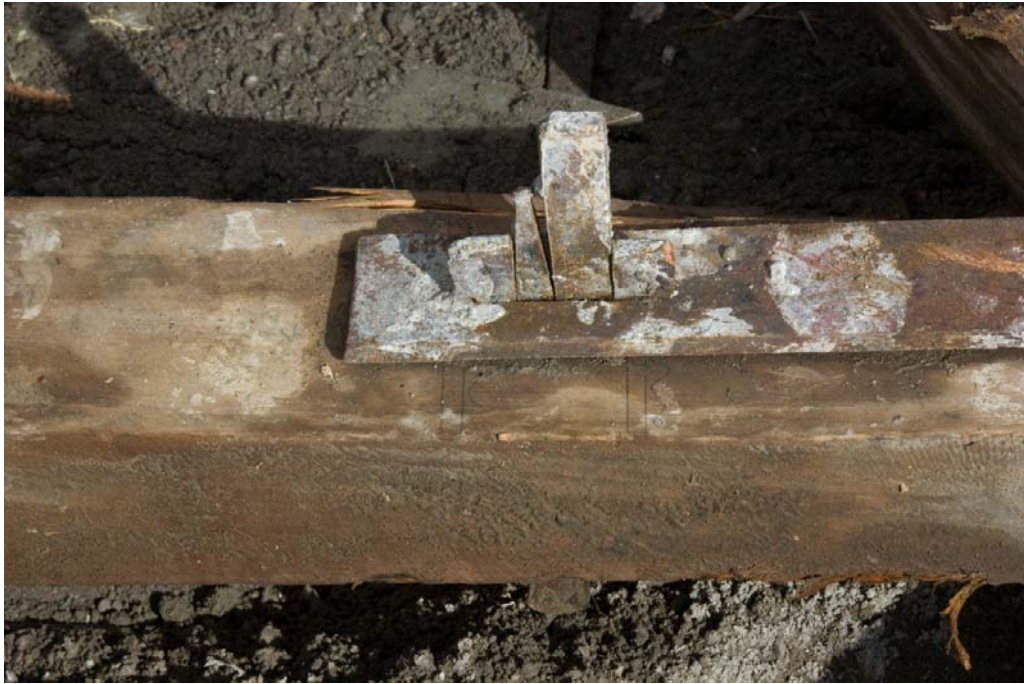
Figure 15. Construction marks and the system of gibs and cotters used to fasten the truss.

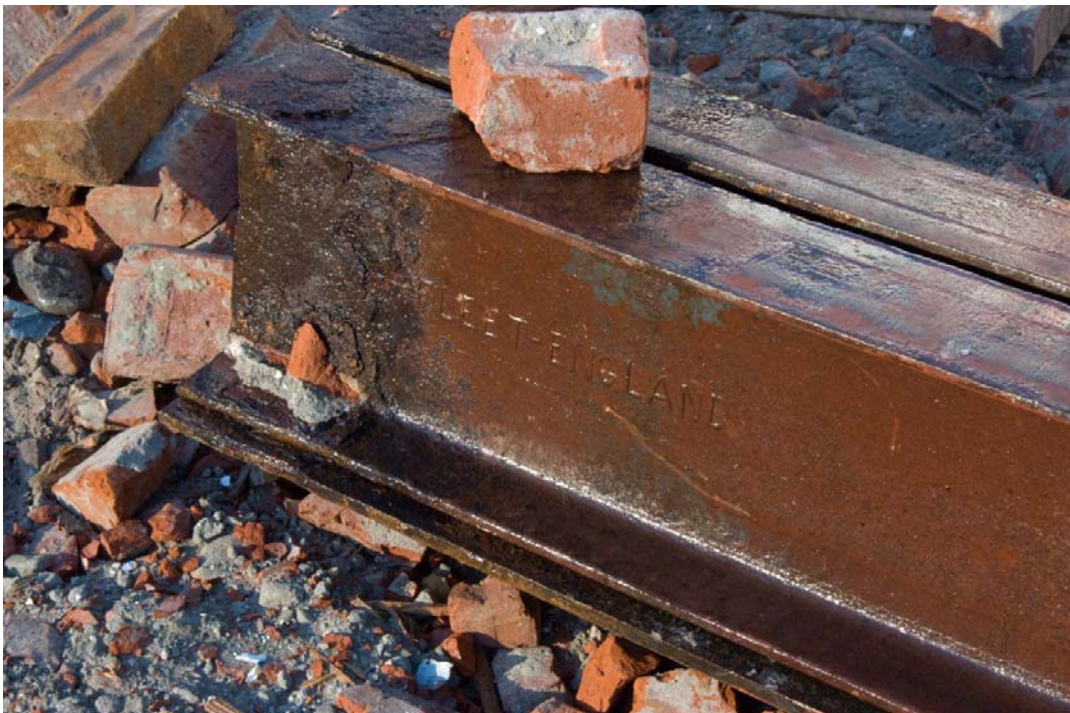
Figure 16. Two Cargo Fleet I-beams that were bolted to a metal plate.

Several I-beams were removed from the building, and probably came from the ceiling/floor between the ground and first floors (Figure 16). No I-beams were observed in any of the external walls, but the I-beams protruded down into the ground floor space and there were metal columns in this space that supported the I-beams (Figure 17). The beams bore the mark 'CARGO FLEET ENGLAND', indicating that they were made by Cargo Fleet Ironworks Company, an English company that operated from 1883-1928 (Grace's Guide 2012). As such, the I-beams were added to the post office after it was built. Cargo Fleet I-beams have also been recorded in a shop on Colombo Street in Christchurch (Watson 2012: 5).

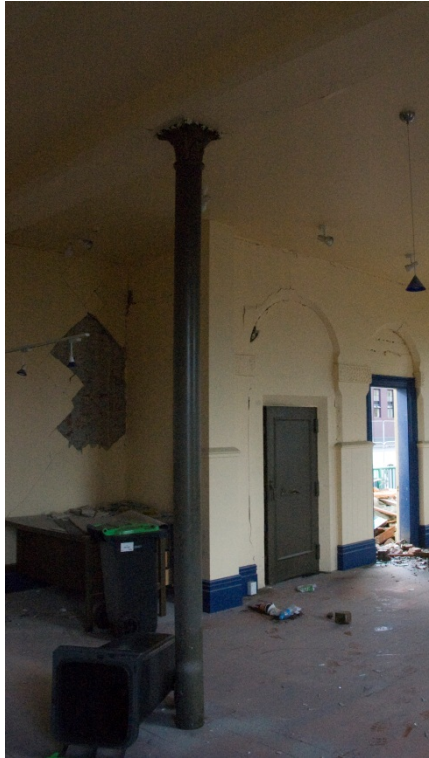
Figure 17. A metal column supporting an I-beam (the casing around the I-beam is visible) on the ground floor.

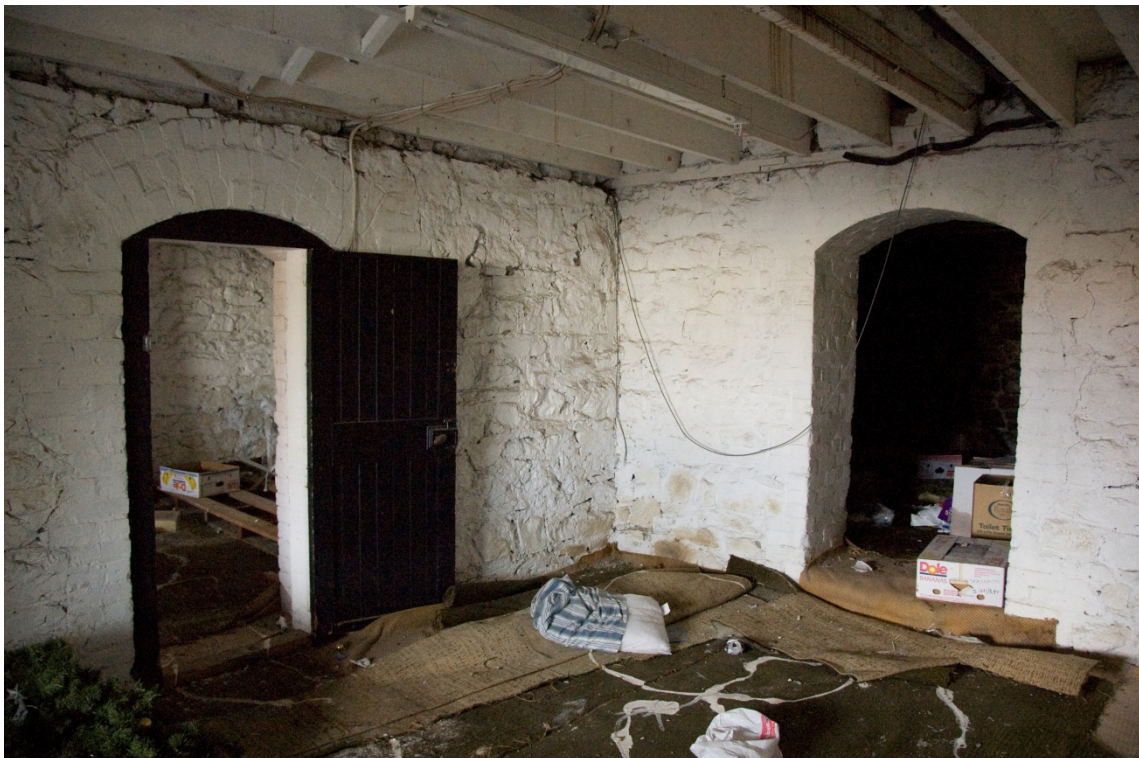
Figure 18. The basement, showing the form of the ground floor above. Note also the form of the arches above the doors.

The floor joists of the ground floor had been left exposed in the basement, meaning that there was effectively no ceiling in this part of the building (Figure 18). Herring bone strutting had been used on the underside of this floor.

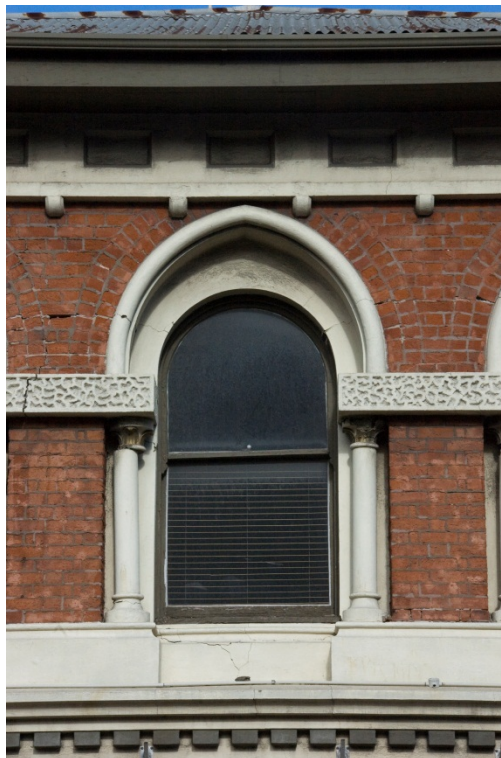
- the windows on the ground floor of the north and east elevations had segmental arches that were one course deep
- the windows on the first floor of the north and elevations had pointed arches that were two courses deep (Figure 19)

Figure 19. The first floor windows on the north elevation (these were the same as those on the east elevation).

There were seven windows on the first floor, all of which were set in the same Portland cement surrounds. These were slightly pointed and had Corinthian columns on each side (Figure 19). The columns supported a vermiculated string course. There was a fourth string course immediately below the eaves of the building (Figure 26).

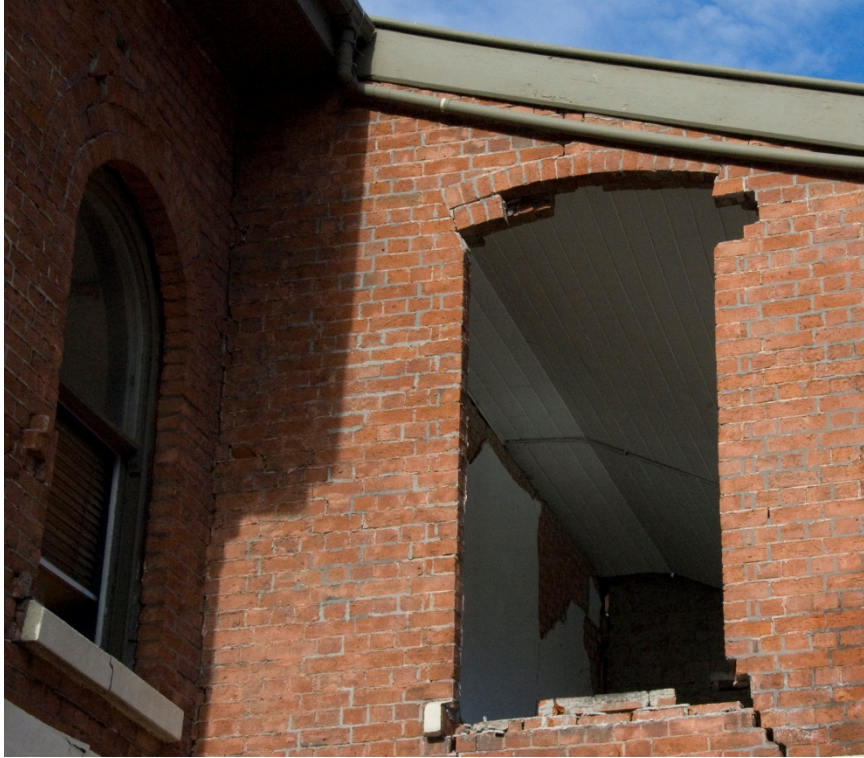
Figure 20. The brick arches on the first floor of the west elevation (left) and the lean-to (right).

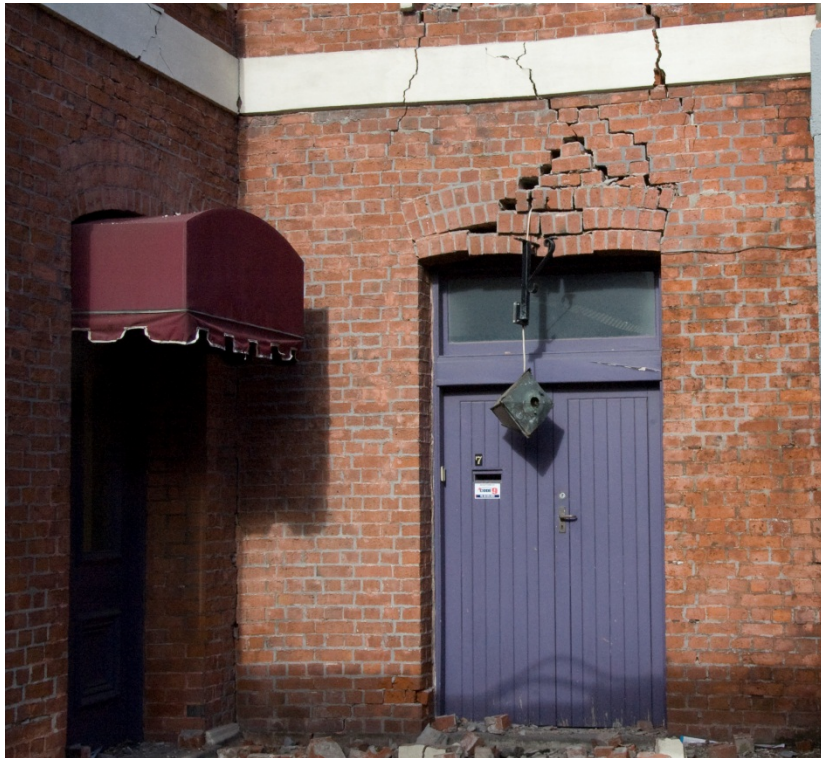
Figure 21. The form of the arches over the doors on the west elevation (left) and the lean-to (right).

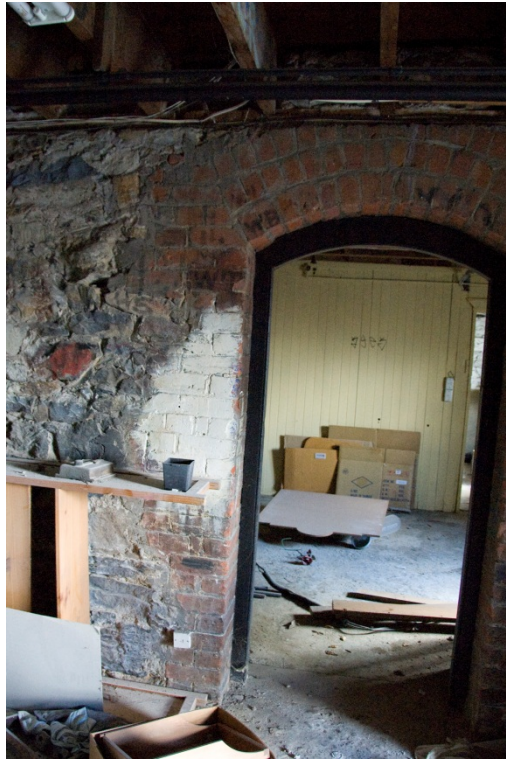
- the arches above the windows in the lean-to were two course segmental arches (Figure 21)
- the arches for the doors in the internal walls the arches on the internal walls of the basement were three course segmental arches (Figure 18) and the doorways were set into brick surrounds (Figure 22)

Figure 22. Brick doorway in the basement.

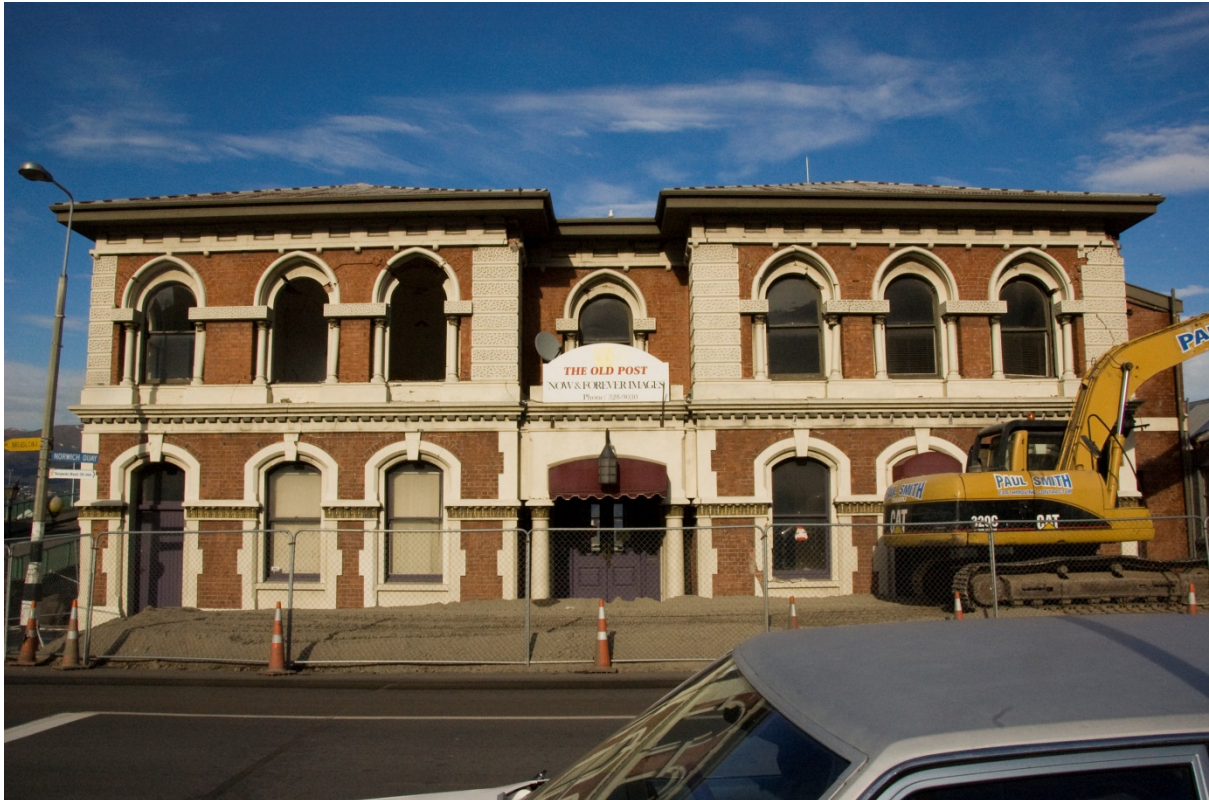
The overall form of the north elevation had been modified little since 1875, although the clock tower that once stood on the northeast corner of the building was removed during the 20th century. The north elevation was divided into three bays, and the central bay, which contained the main entrance, was recessed (Figure 23). The main entrance consisted of double wooden doors (with glass panes in the upper half of the door) and two Corinthian columns on each side, complete with acanthus leaf capitals (Figure 24).

Figure 23. The north elevation of 7 Norwich Quay.

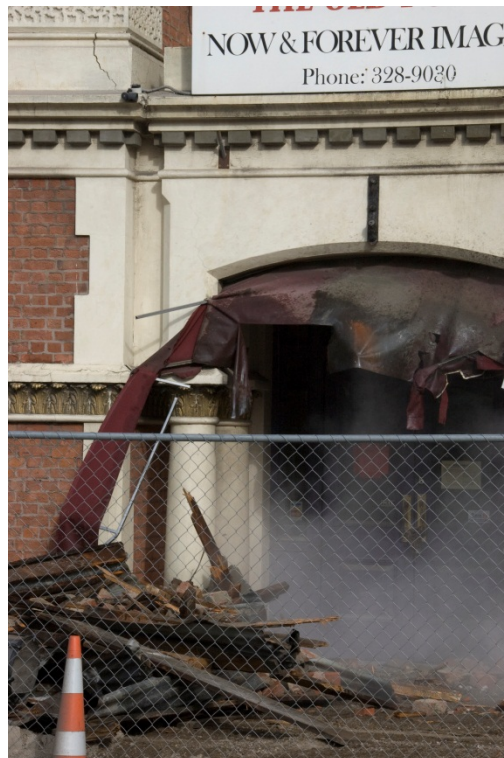
Figure 24. The main entrance to 7 Norwich Quay.

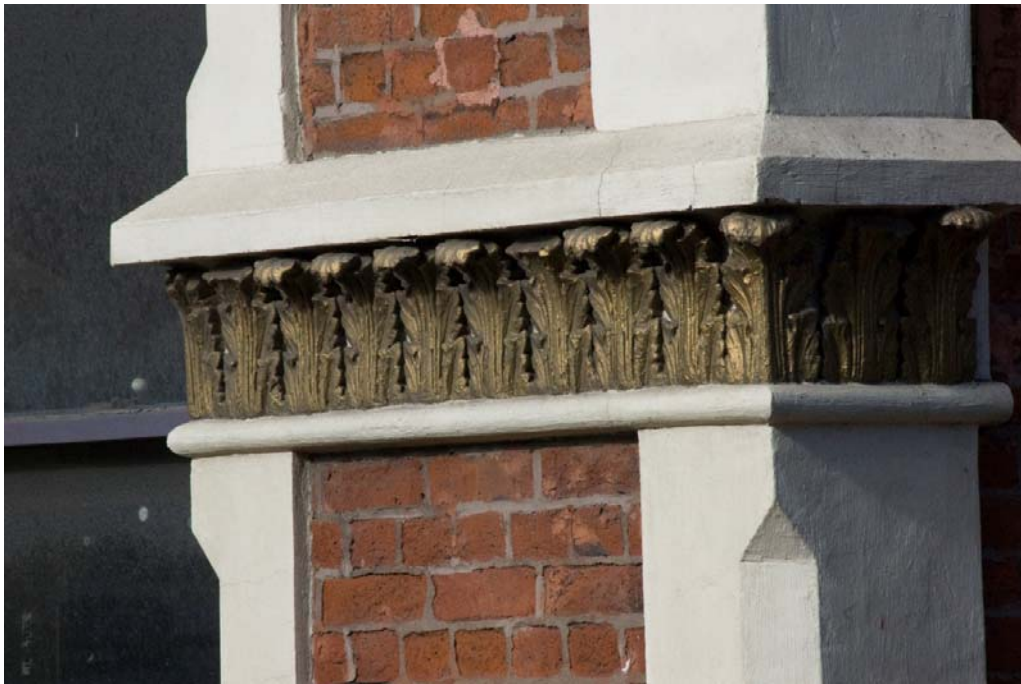
Figure 25. The acanthus leaf string course on the ground floor.

keystone at the apex. The doors and windows were connected by an acanthus leaf string course roughly half way up the windows (Figure 25). There was also a string course between the ground and first floors, which included dentils.

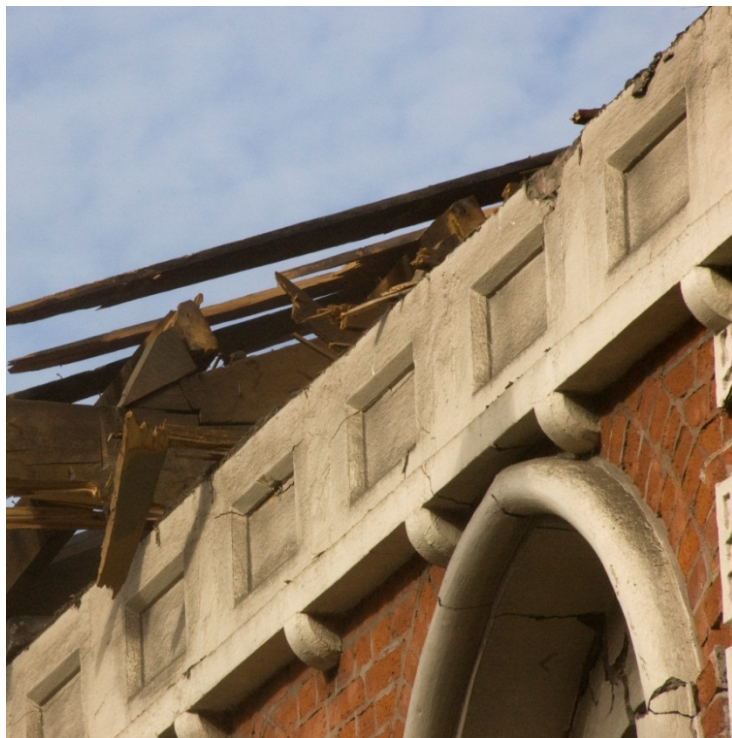
Figure 26. The string course immediately below the eaves of the building.

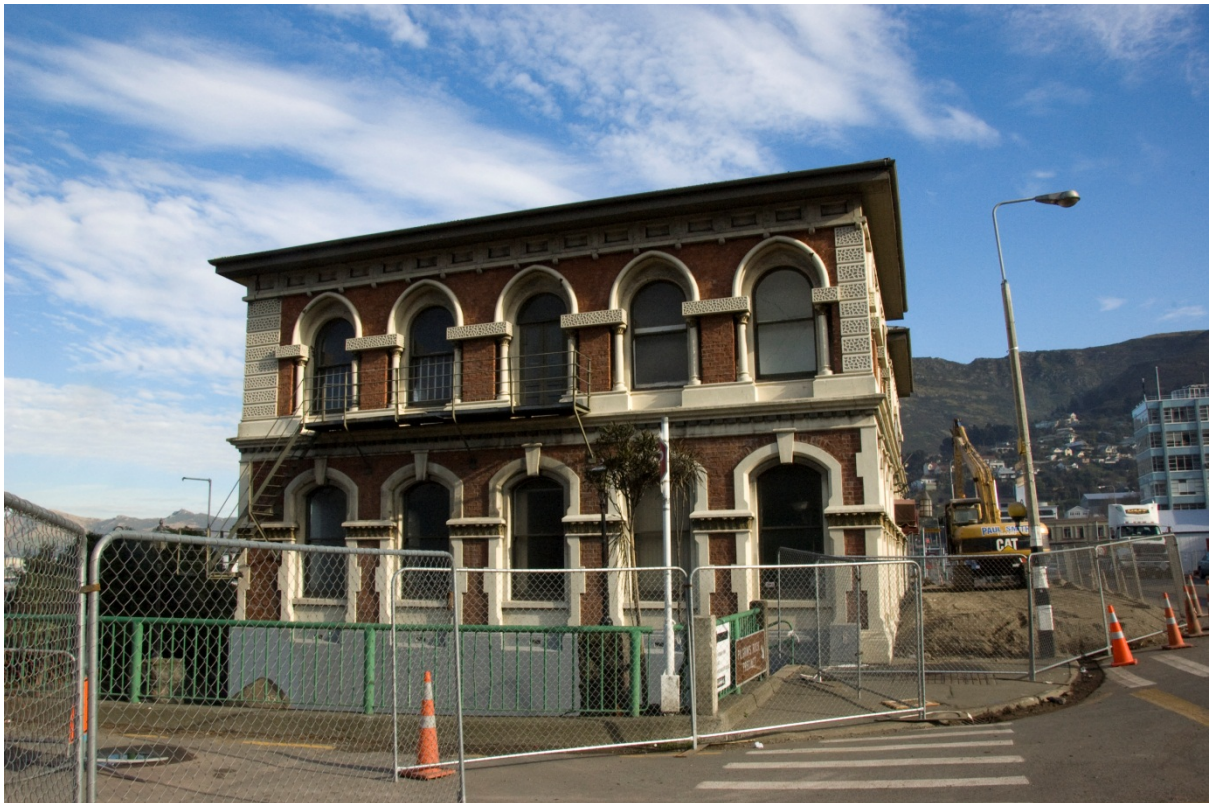
The east elevation was largely the same as the north elevation in terms of its appearance, with five windows on each floor (Figure 27). One of the windows on the first floor had been converted to a door, and a fire escape had been added to this elevation. The basement was also visible here, and there were no doors or windows in it.

Figure 27. The east elevation.

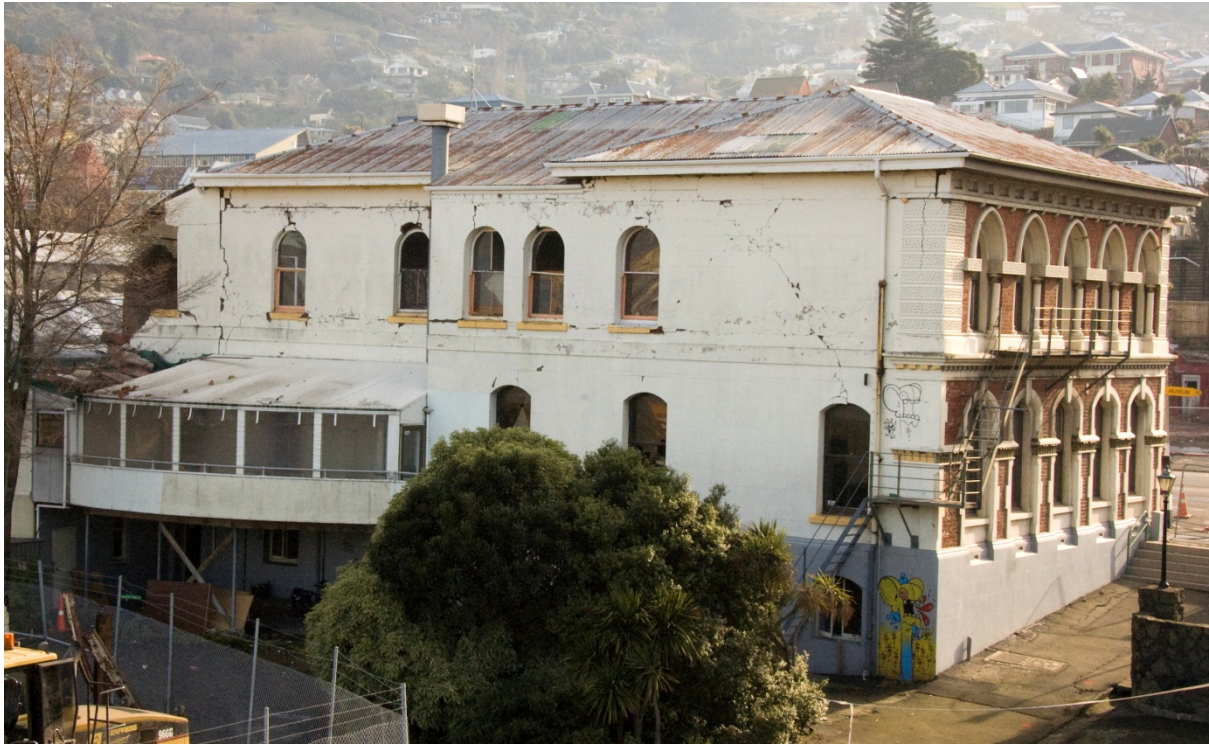
The south elevation was very plain, with no decoration, and it is worth bearing in the mind that the 1875 description of the building notes that this elevation was covered in cement to prevent it from storm damage (Figure 5 and Figure 28). Further, this elevation would have been seen less by the public than the north or east elevations.

The first floor had originally had at least six sash windows, which had curved heads. Some of these had subsequently been converted to doors, to provide access to an enclosed balcony that had been added to this elevation. The first floor had at least five sash windows, with round heads. The bottom panes of these sash windows were two-light windows. The basement had a number of casement windows and at least one door.

Figure 28. The south elevation.

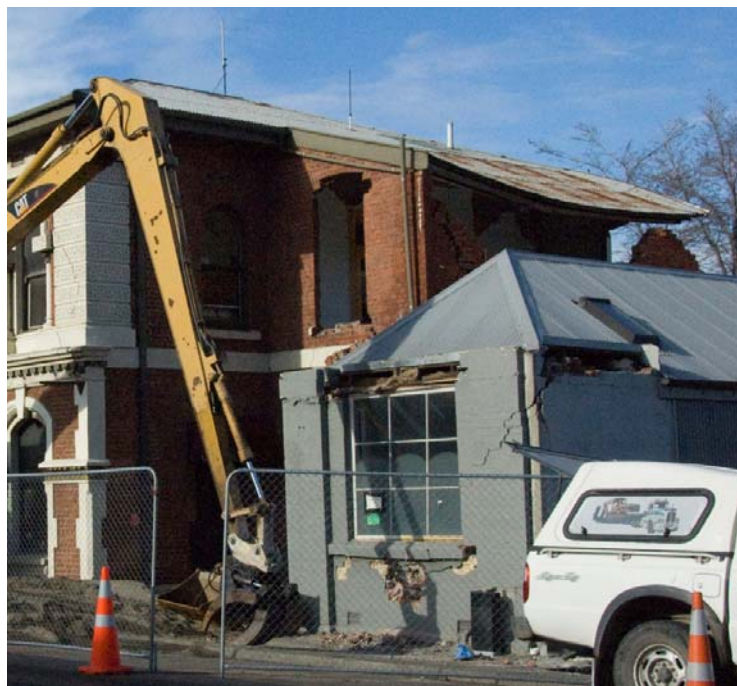
Most of the original west elevation had been obscured by a two-storey lean-to added in the 1880s or later (Figure 29). This elevation had a door on the ground floor (Figure 21) and a sash window above (Figure 20). This door appeared to be original and had one diamond-head pane on the lower third and a glass panel above. The window was a sash window. The two floors were visually separated by a plain string course. The only other detailing on this elevation was a plain Portland cement window sill on the first floor window and a metal downpipe embossed with a floral motif (Figure 30). This was probably original.

Figure 29. The west elevation.

The two-storey lean-to had partly collapsed in the earthquakes (Figure 29). The north elevation of this had a door on the ground floor (Figure 21) and a window above (Figure 20). The door was a timber board door with a fanlight above and appeared to be wider than a typical door. The plain string course on the west elevation of the main building continued at least along the north elevation of the lean-to.

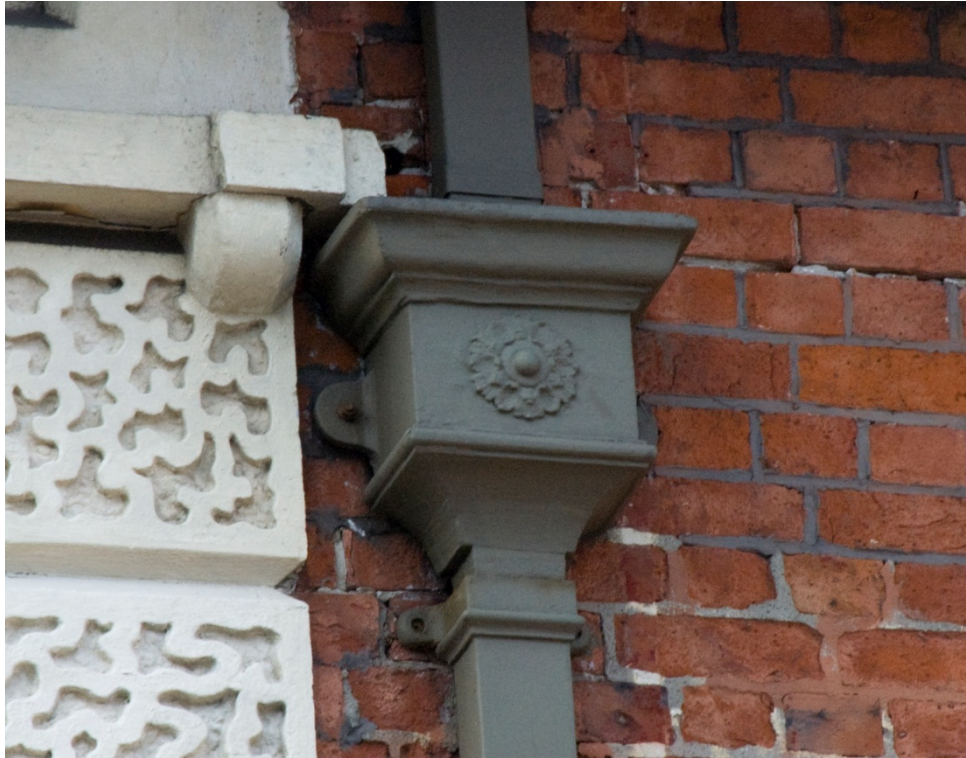
Figure 30. The downpipe on the west elevation.

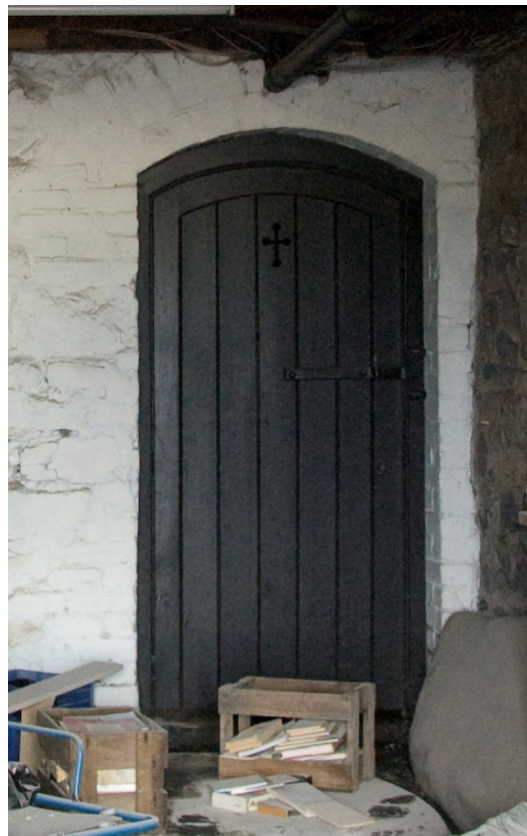
Figure 32. A door in the basement area.

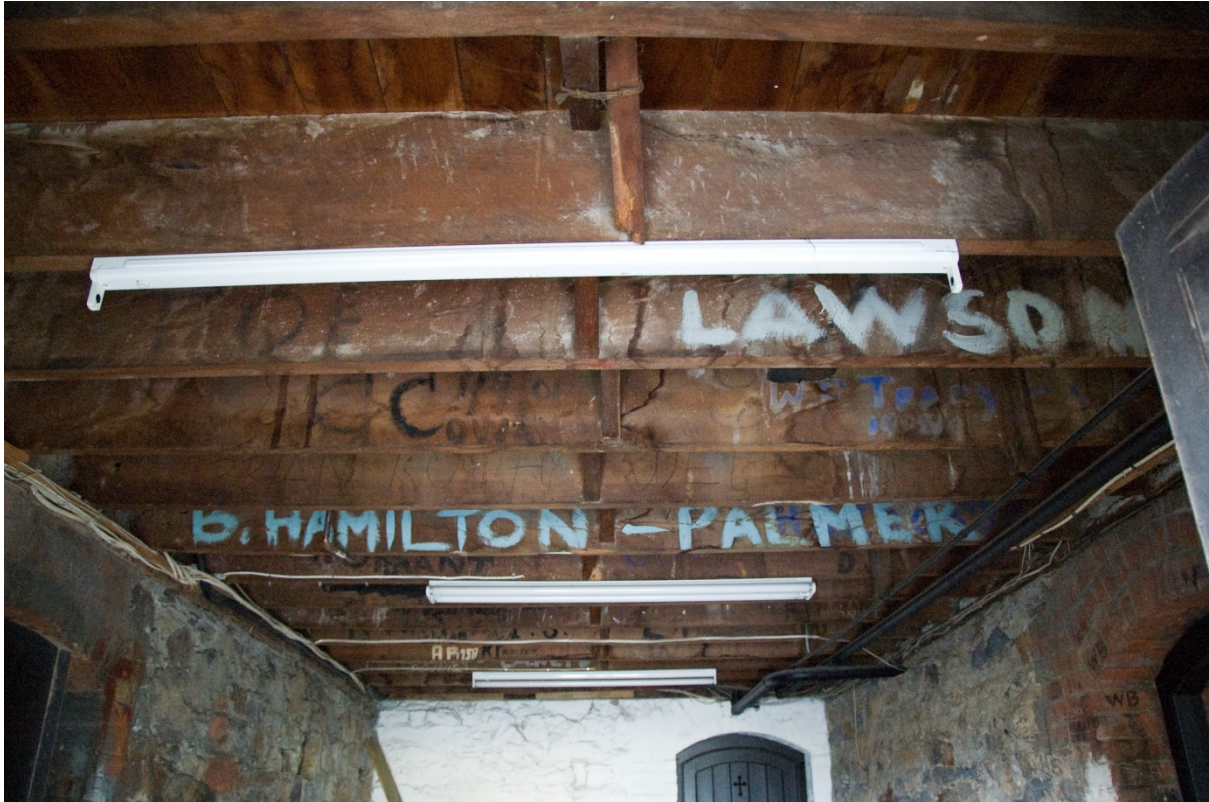
The basement was inspected only briefly prior to demolition and little of it could be observed after demolition began, as the building was essentially collapsed into it. Plans of the building, however, were drawn in 1999 and were accurate for this area (Figure 31). Further, this area appeared to have been little modified with the passage of time. There were eight rooms, each walled with Portland cement, which had been lined with stone and the doorways formed with bricks (Figure 18 and Figure 22). The doors were original and were batten doors, with a heavy bolt and a cross cut out of the door (Figure 32). Graffiti, which appeared to be relatively modern, remained on the exposed floor joists above (Figure 33).

Figure 33. Graffiti on the ceiling of the basement.

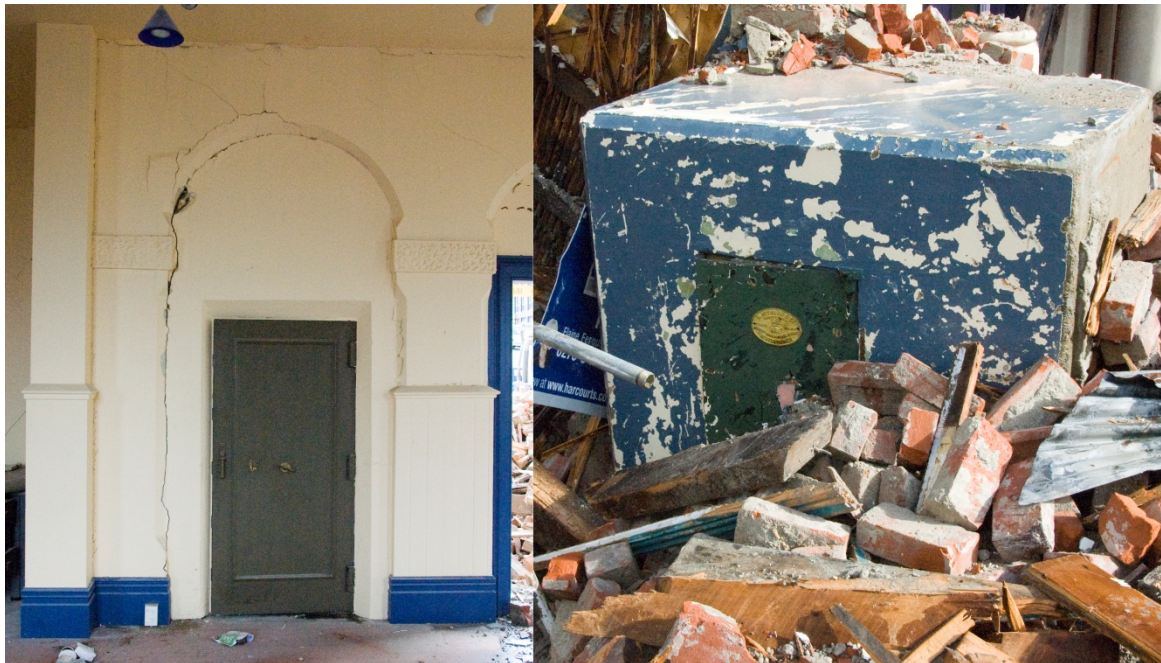
Figure 35. Left: The door into the safe. Note also the timber dado and the vermiculated quoins on either side of the door. Right: The safe.

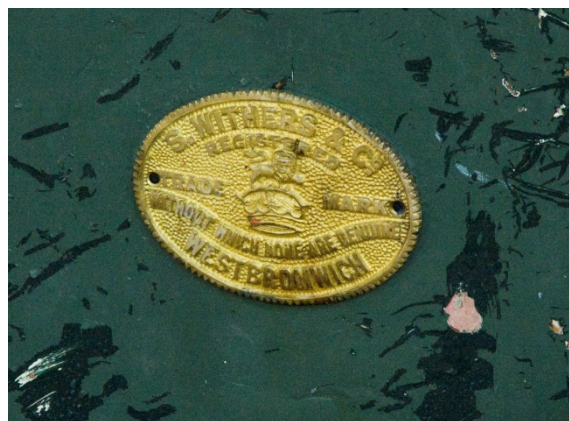
Figure 36. The maker's plate on the safe.

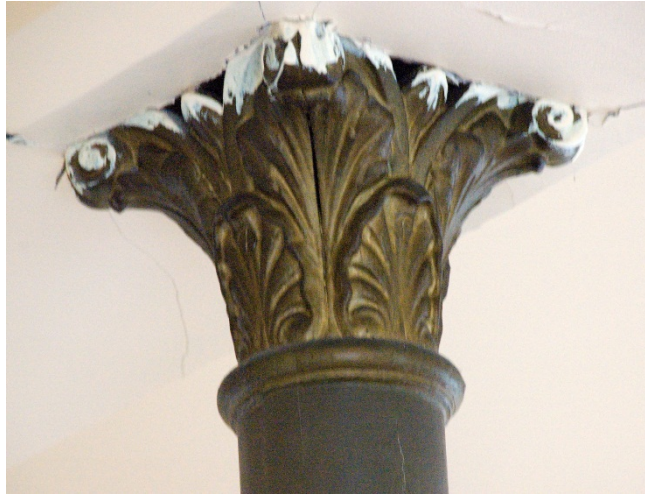
Figure 37. The capital of one of the metal columns in the restaurant.

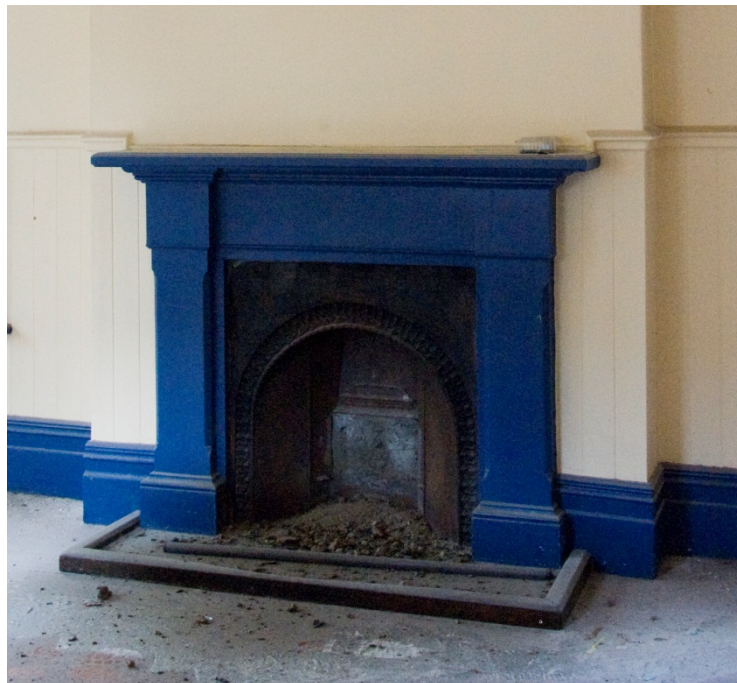
Figure 38. The restaurant fireplace.

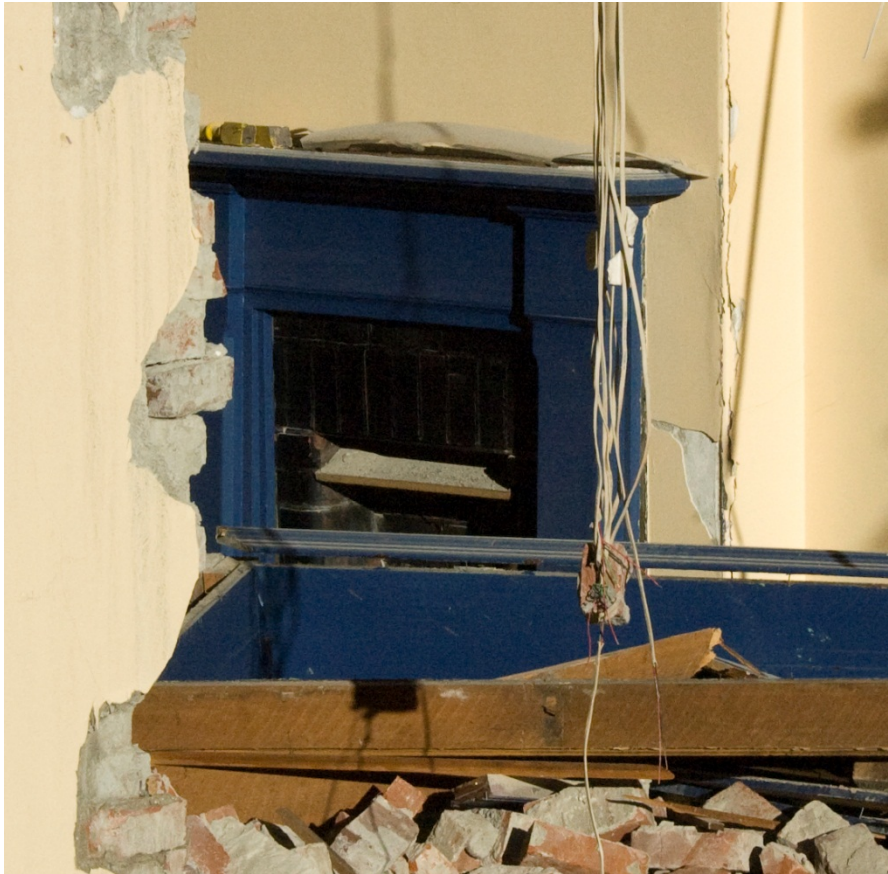
Figure 39. The fireplace in the room to the south of the office. This did not have a coal register but the form of the fire surround was the same as that in the restaurant.

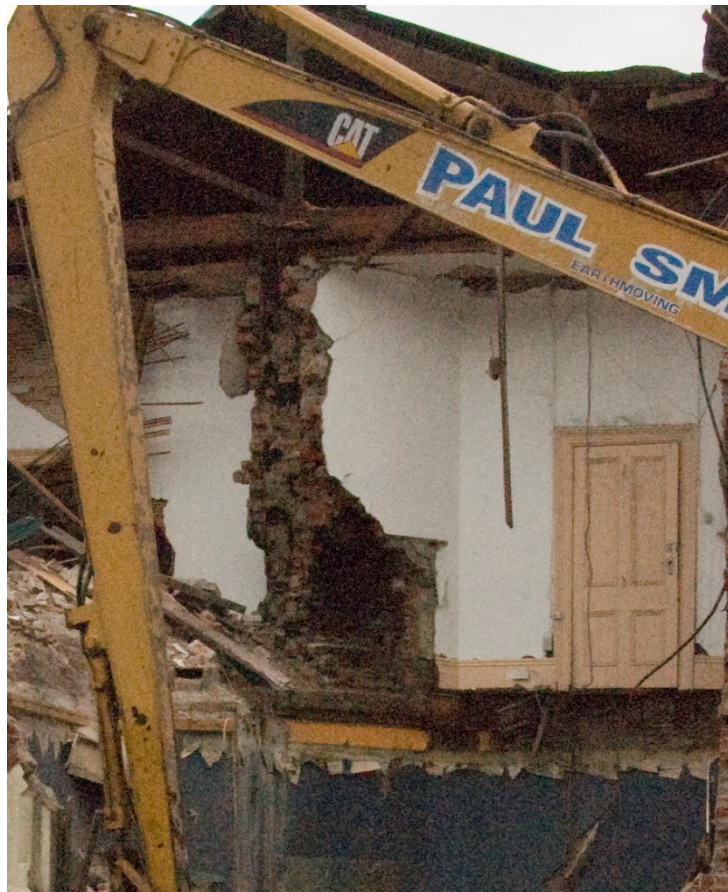
Three fireplaces remained in the building: a corner fireplace above the ground floor corner fireplace (Figure 41), a fireplace on the south wall above that in the ground floor office and a fireplace above that in the bar. The fireplace on the south wall was notable for being wider than the fireplace on the ground floor below (Figure 42).

Figure 41. The first floor corner fireplace.
