7 NORWICH QUAY, LYTTELTON: REPORT ON ARCHAEOLOGICAL MONITORING

NZHPT AUTHORITIES 2012/108EQ & 2012/256EQ

ANDY DODD AND KATHARINE WATSON
UNDERGROUND OVERGROUND ARCHAEOLOGY LTD

NOVEMBER 2012

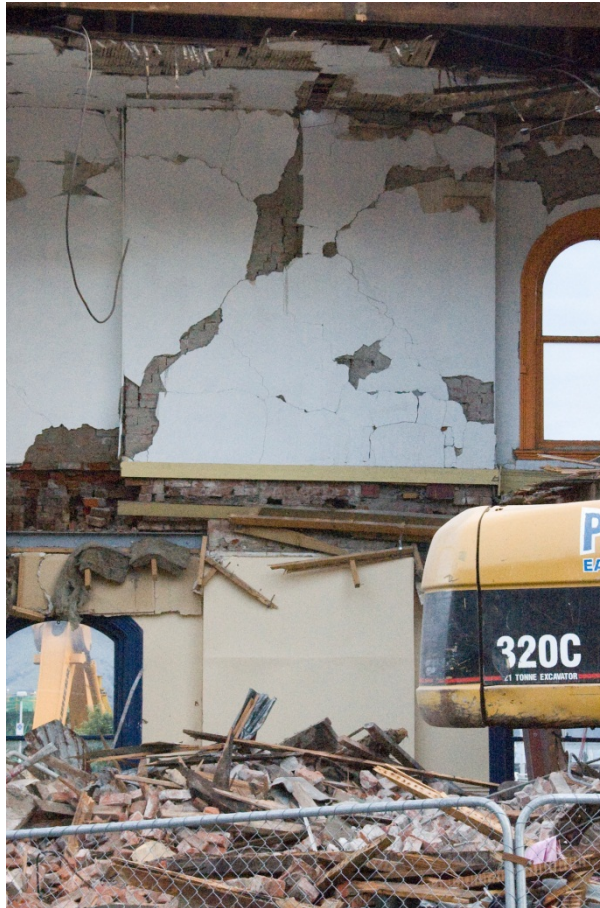
Three fireplaces remained in the building: a corner fireplace above the ground floor corner fireplace (Figure 41), a fireplace on the south wall above that in the ground floor office and a fireplace above that in the bar. The fireplace on the south wall was notable for being wider than the fireplace on the ground floor below (Figure 42).

Figure 42. The ground and first floor fireplaces on the south wall of the building. Note the width of the first fireplace in relation to that on the ground floor.

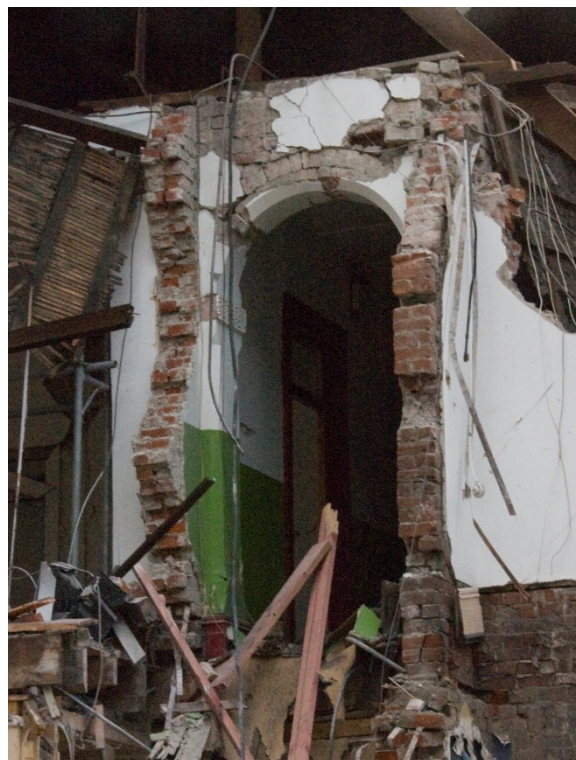
Other features observed on the first floor were two arched doors in the hall (Figure 43).

Figure 43. An arched door in the first floor hallway.

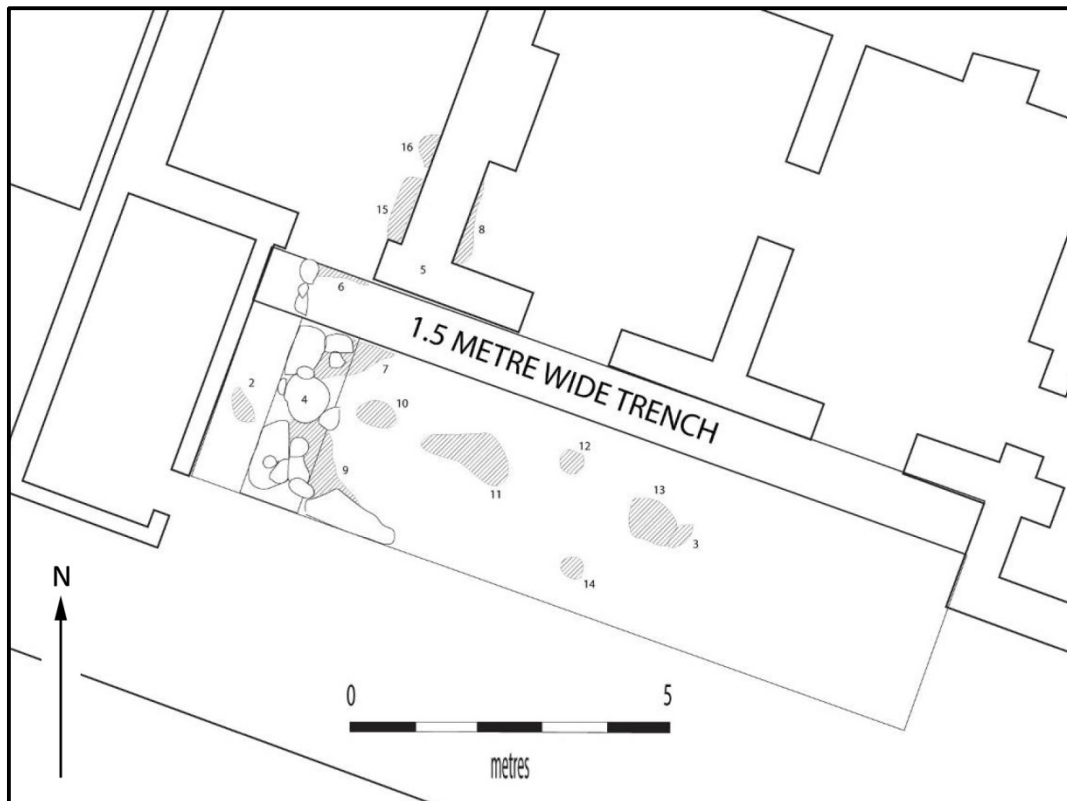
Figure 45. Detail of Figure 44, showing the features in more detail.

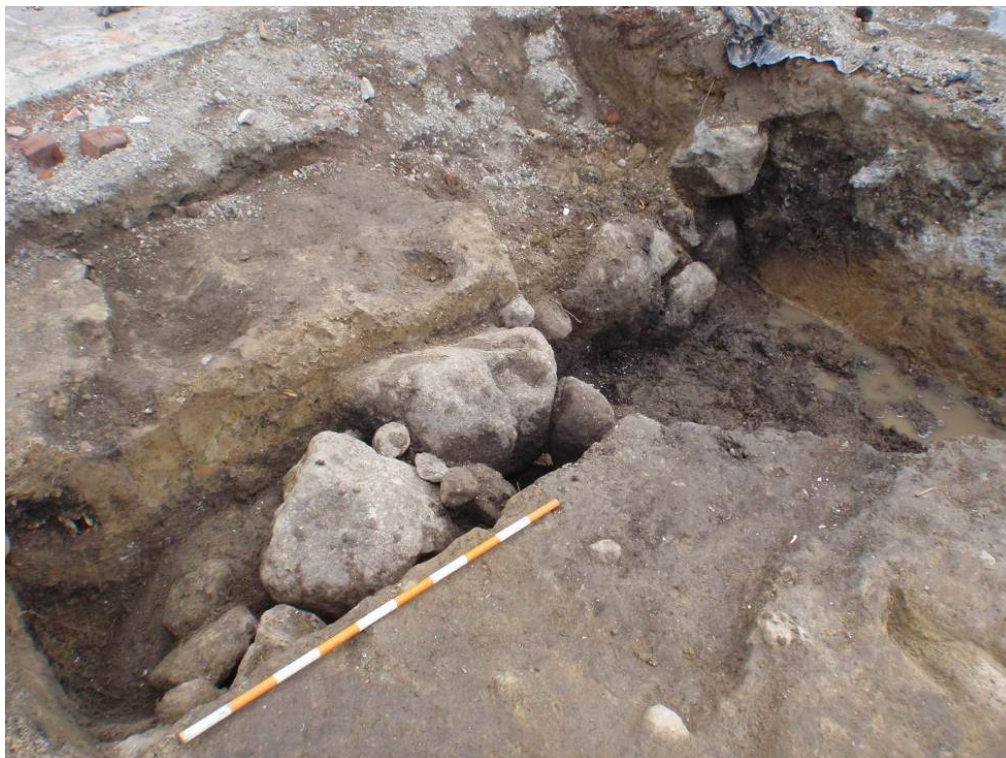
Figure 46. Feature 4 exposed in excavation with Feature 6 in the background. Feature 6 was truncated by the 1849 seawall, and both were subsequently truncated by the 1875 concrete foundations (Feature 5; 11.10.11).

Feature 4 was a seawall, which is believed to date from 1849 (Figure 46). The wall comprised an alignment of small to medium-sized rounded boulders on a roughly north-south orientation. Further investigation of the area under the concrete pad to the west of this feature, and of the unmodified ground to the south, may help to further define the orientation and extent of the wall. The second trench running roughly north-south was excavated to assist with the definition of this feature. Remnants of a seawall were also found during the archaeological monitoring of the section at 11 Norwich Quay to the west carried out by Opus International Consultants (N. Cable, pers. comm.).

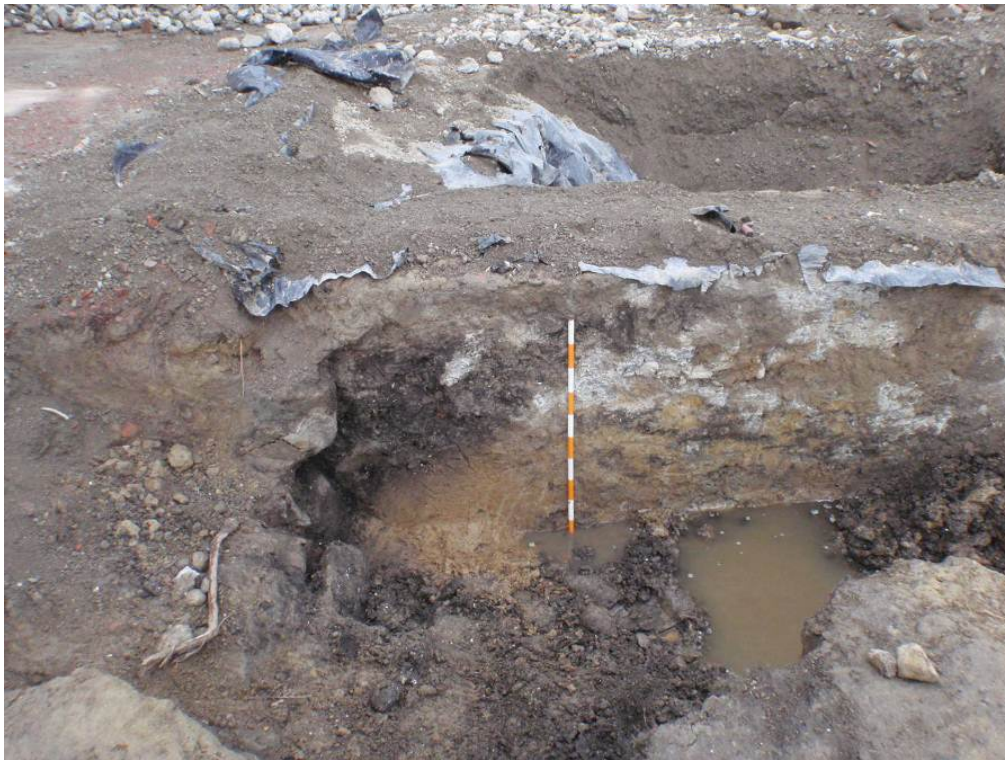
Figure 47. Feature 6, exposed on the south side of the concrete foundation (Feature 5; 11.10.11).

Feature 6 was an oven exposed on the north side of the trench (Figure 49 and Figure 48). This feature was largely destroyed during the excavation of the trench (literally taken out with one bucket scoop). The form and profile of Feature 6 was able to be recorded because of the dark stain the oven deposit left on the south side of the concrete foundation. On the basis of form, appearance and stratigraphy it is probable that Features 6 and 7 are contemporary, and possibly even two ends of the same feature. Feature 6 had been truncated twice during the history of the site, the first time

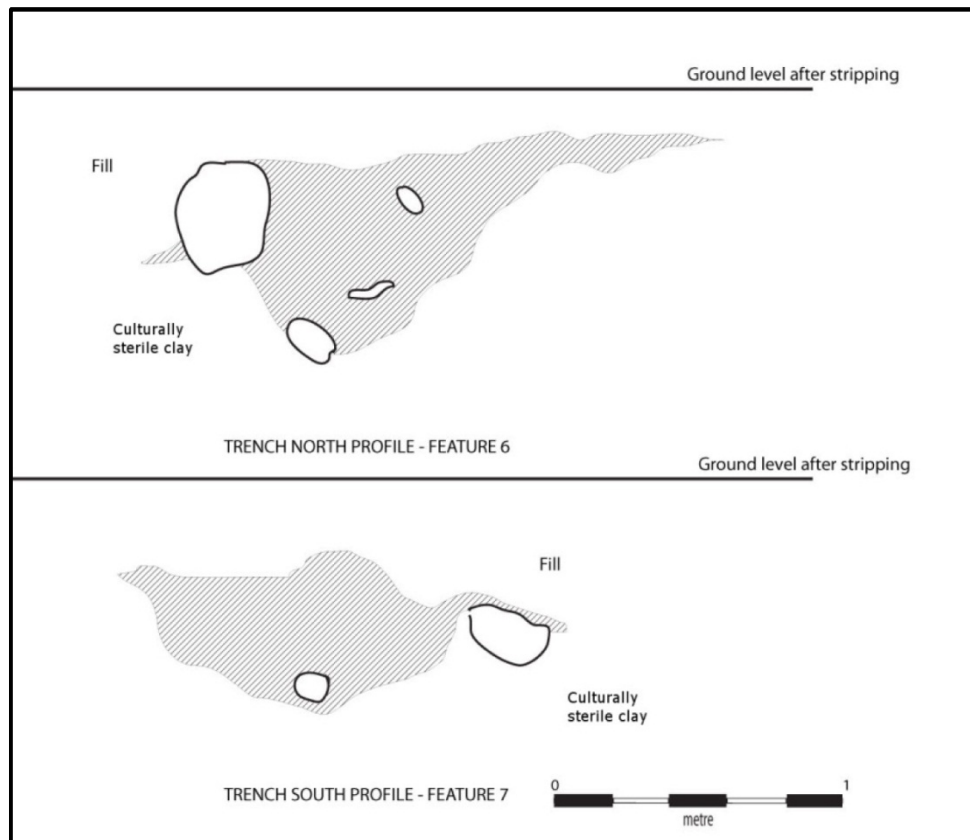
Figure 48. Profiles of Features 6 and 7 exposed in trench

Feature 6 was 1.5 m long and up to 600 mm thick, tapering away on the eastern end. The depth from the artificially reduced ground surface at the top of the concrete foundations was between 200 and 300 mm. Feature 6 contained the largest sample of shell of all the features, including catseye, pāua, Bluff oyster, blue mussel, silver pāua, turret shell, green lipped mussel, and speckled whelk (there is a full list of the faunal remains in Appendix 3). Fish species included shark/ray and red cod, and bird species included New Zealand wood pigeon and species that were not able to be identified from the Otago University reference collection. Rat and dog bone were also present in the sample.

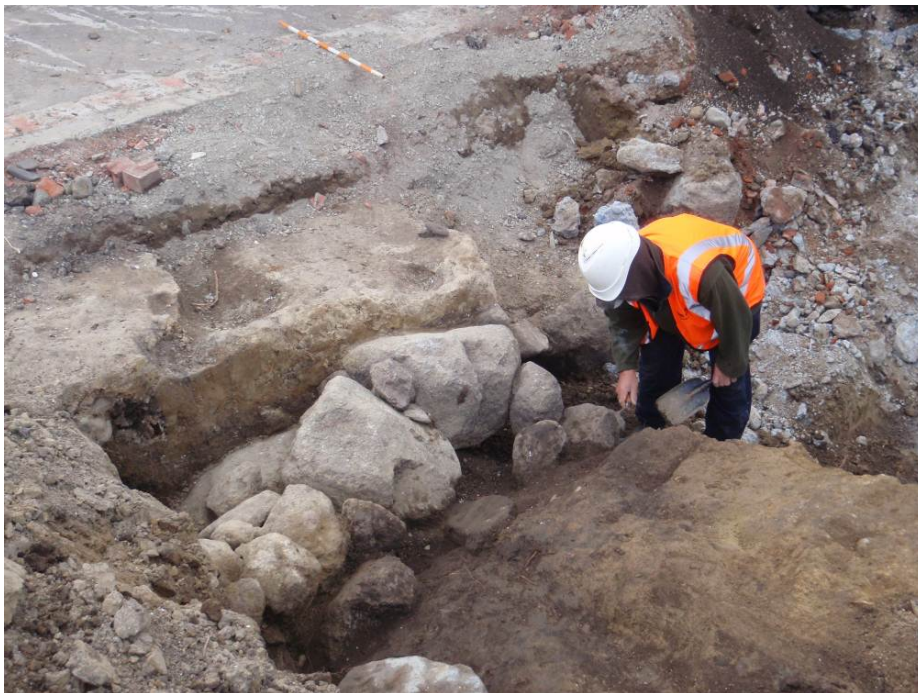
As discussed above, Feature 7 may have been part of Feature 6, exposed on the south side of the west-east trench excavated to remove the concrete footing (Figure 49). The sample of cockle shell selected for radiocarbon dating was taken from this feature and returned a calibrated date of AD 1465-1660 at 95% confidence. As with Feature 6, Feature 7 was partially destroyed during the initial trench excavation, and had been truncated by the 1849 construction of the seawall (Figure 48 and Figure 50). Feature 7 was 1.2 m long and up to 500 mm thickness, tapering away on the eastern end. The depth from the artificially reduced ground surface at the same level as the top of the concrete foundations was between 200 and 300 mm. Feature 7 contained a reasonable quantity of shellfish fragments including remains of Bluff oyster, catseye, pāua, blue mussel, turret shell, mud snail and pipi. Bird bone recovered from this feature included little shag, spotted shag, tui, New Zealand wood pigeon, blue penguin, moa bone and parakeet. Fish bone included kahawai, red cod and ling. As with Feature 6, rat and dog bone were also present.

Figure 49. Rewi Couch excavates Feature 7 alongside the 1849 seawall (14.10.11).

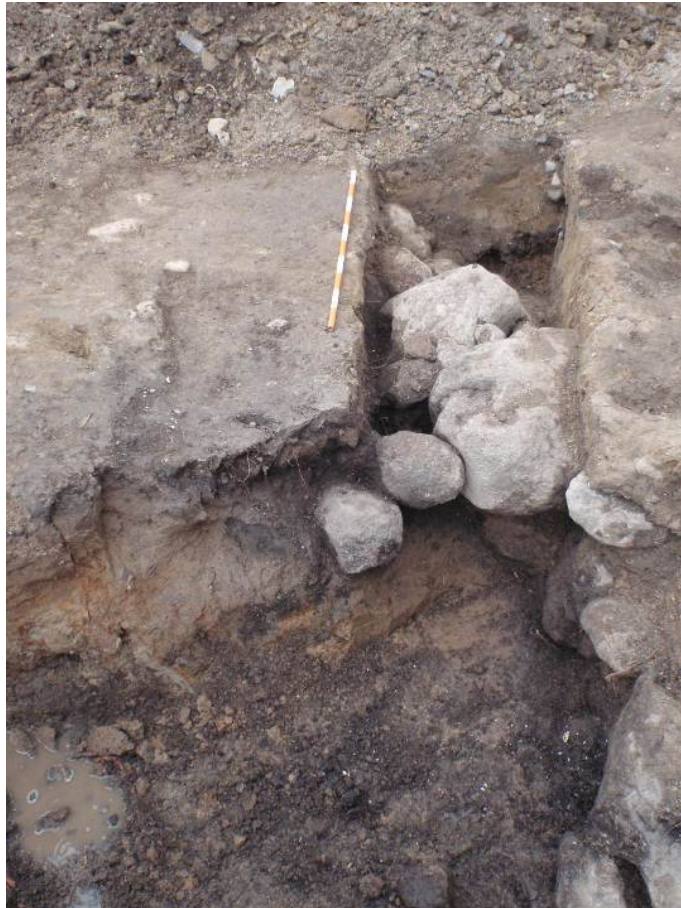
Figure 50. Feature 7, truncated by the 1849 seawall.

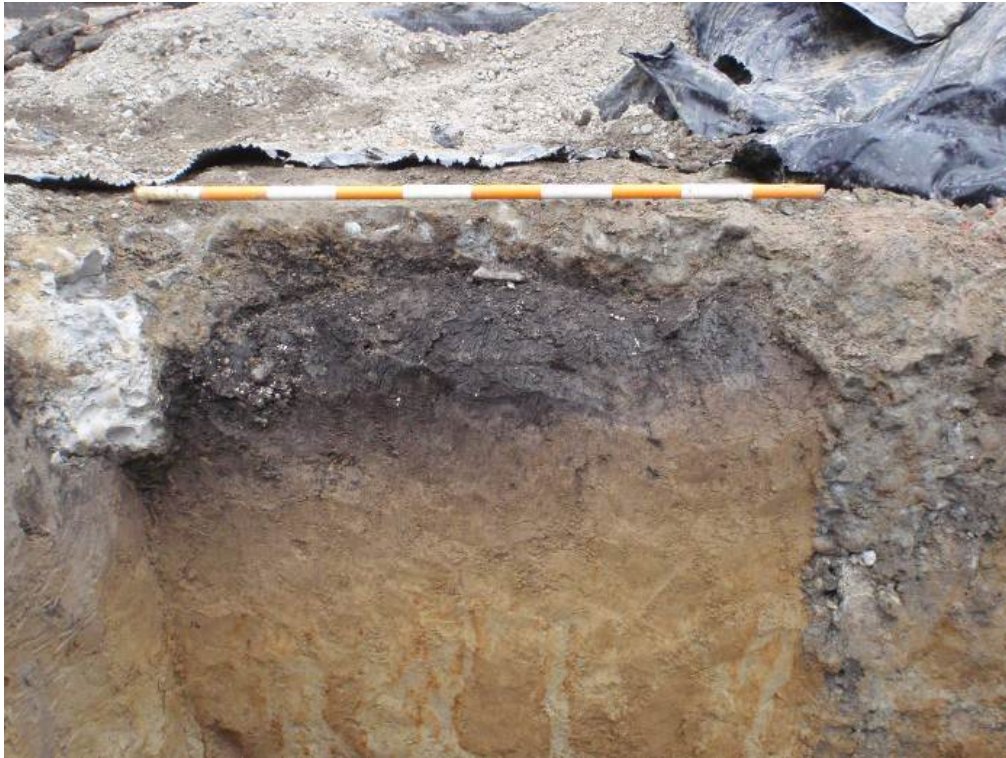
Feature 8 was located on the opposite side of the 1875 concrete foundation from Feature 6. As a result, this feature had been truncated by the post office construction and only a small portion remained (Figure 51). This was a band of dark stained soil containing shellfish and fish bone, which was up to 250 mm thick and was 100 mm below the top of the foundations. Shellfish remains included blue mussel, catseye and pāua. Fish species were limited to sharks and rays. Bird species included New Zealand wood pigeon and moa bone, and rat bone was also present.

Figure 51. Feature 8 viewed from the east side (11.10.11).

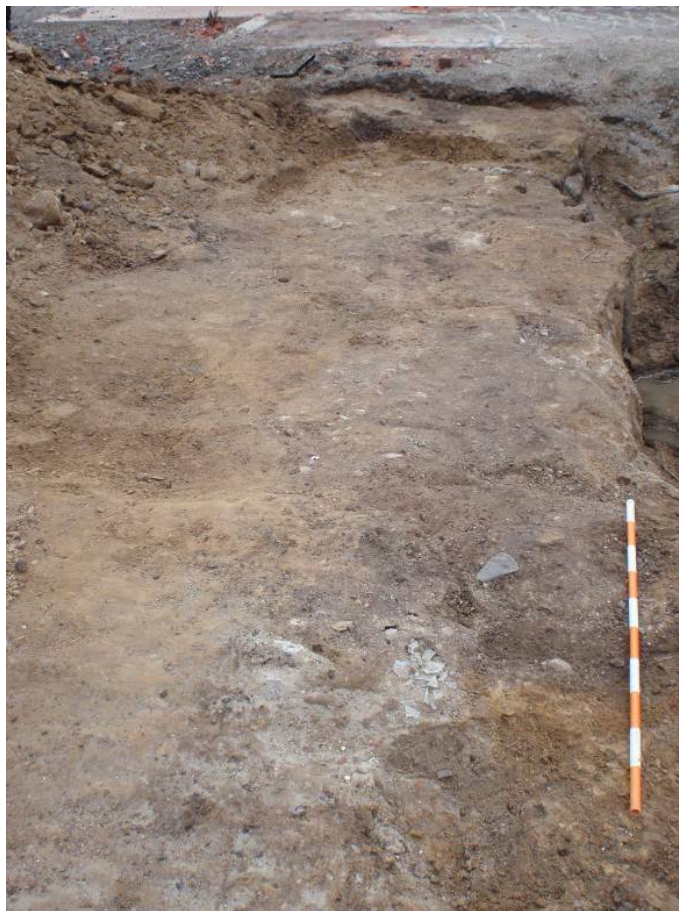
Feature 13 was a shallow deposit of black stained soil smeared over an area 800 x 500 mm (Figure 52). It included fragments of crushed mussel and catseye, as well as a broken stone adze, and a small amount of kōkōwai (red ochre).

Figure 52. The site after the initial scrape down, with the broken adze lying in situ next to the 1 m scale (10.10.11).

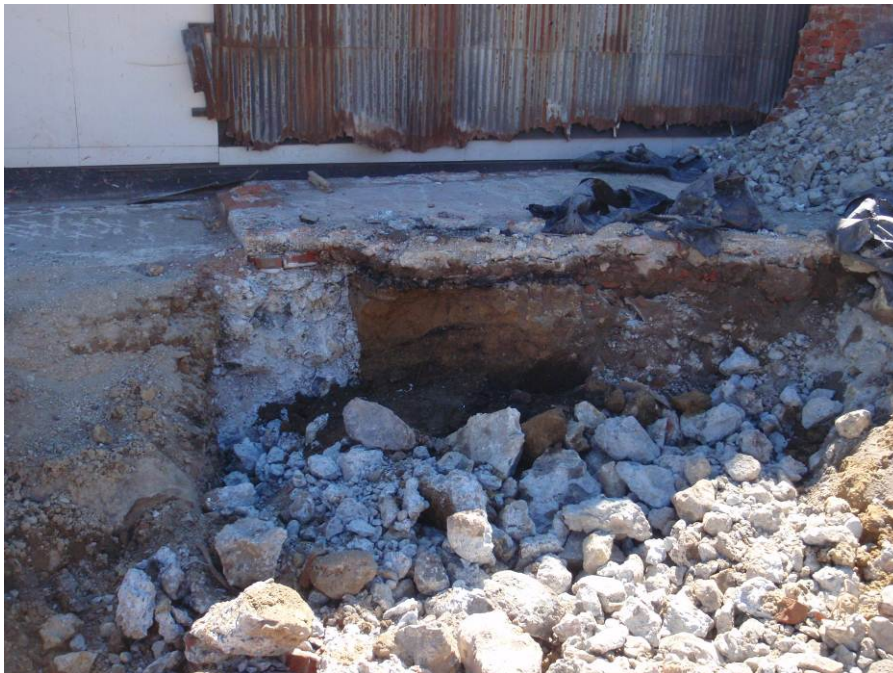
Feature 15 was encountered as a thin lens of midden in blackened soil up to 60 mm thick (Figure 54 and Figure 53). Shellfish from Feature 15 included Bluff oyster, blue mussel, catseye, chiton sp., pāua

Figure 53. Feature 15 exposed under the concrete slab on the west section boundary.

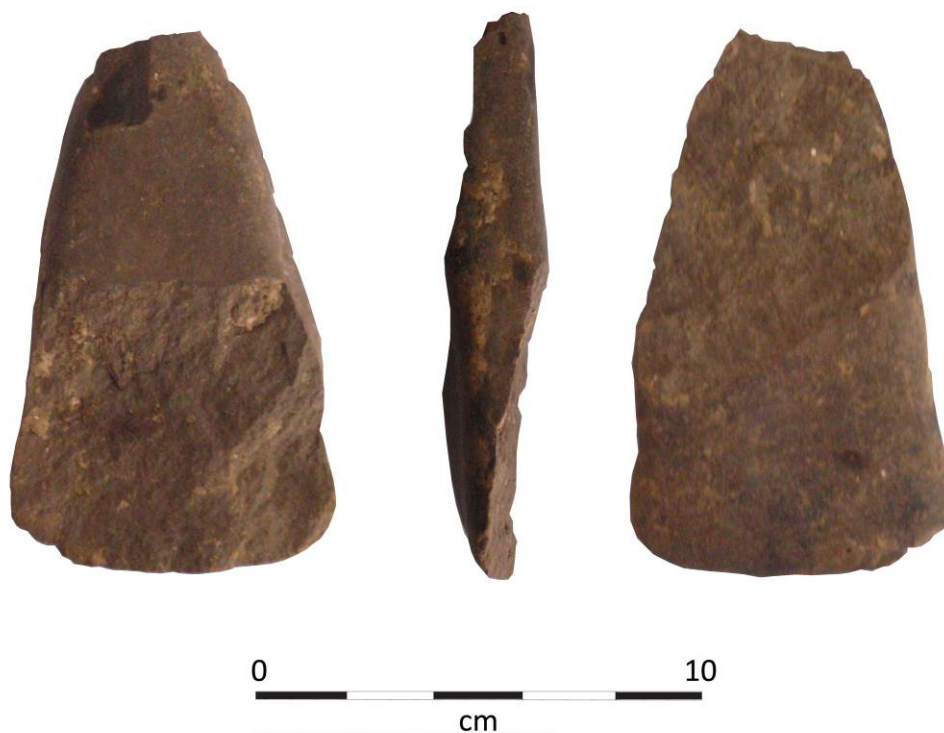
A single greywacke Type 2 stone adze was recovered during investigation (Figure 55). In the Duff classification, Type 2 adzes are of quadrangular cross-section, without a tang or lashing grip (Duff 1977:162-170). The adze retains its overall shape, dimensions and cross section towards the poll or butt of the adze, but has been heavily flaked. The flaking represents a failed attempt at shaping or reworking the adze, and the adze was probably discarded during this process. The adze has been notified to the Ministry of Culture and Heritage and given the number Z11102.

Figure 55. Stone adze recovered from Feature 13, 7 Norwich Quay.

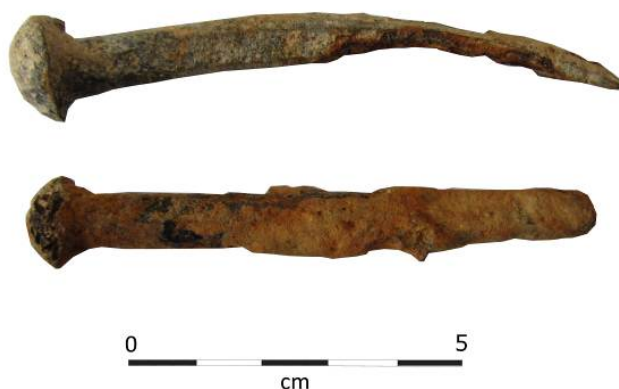
Five nails, a screw and an unidentified piece of copper were recovered from the site. The nails were of an earlier form, being square cut with rounded or square shaped heads (Figure 56).

Figure 56. Square nails with rounded heads.

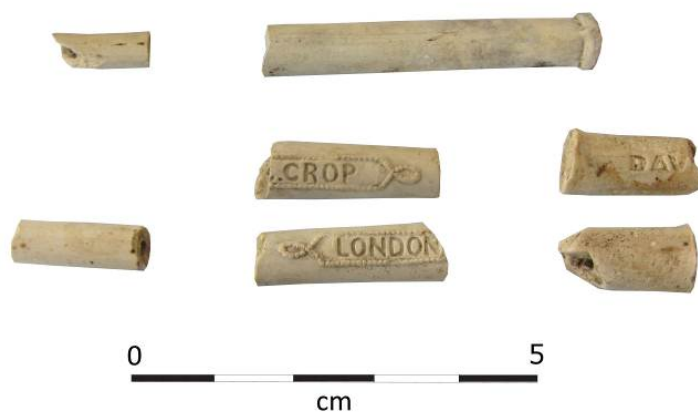
Five clay pipe fragments were recovered from the site. One pipe stem fragment was impressed with the mark "C.CROP" and "LONDON" on the reverse (Figure 57). Charles Crop & Sons was a London-based clay pipe manufacturer who operated between 1856 and 1924 (Oswald 1975:205). Another stem had the mark "DAV...". This was probably Davis, Davies or Davidson which were all manufacturers of clay pipes. Without more of the impressed mark it is not possible to determine an origin or date of manufacture for this fragment.

Figure 57. Clay smoking pipe stems recovered from Feature 2.
